Limited Visual Dam Safety Inspections

OA00019

Opaepa 02 Reservoir

May 2006

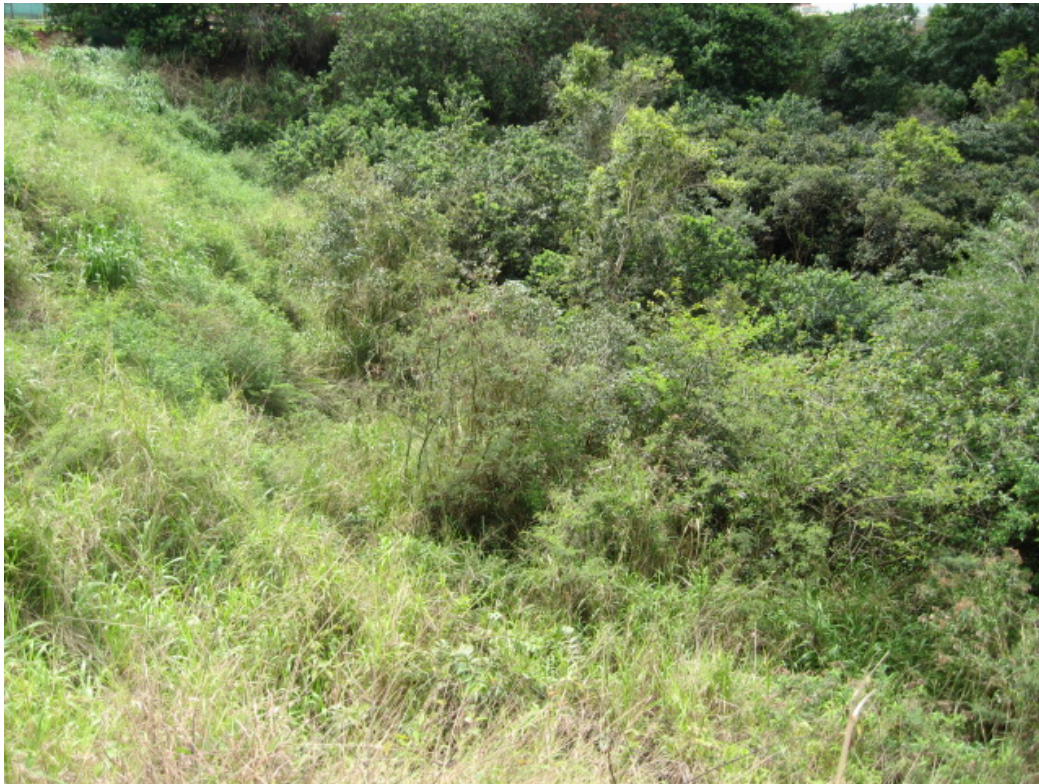
The downstream slope was in poor condition and not visible due to heavy vegetation.

Vegetation was observed on the downstream slope. The vegetation consisted of bushes, tall grass and woody trees ranging from 6" to 2 feet in diameter.

- a. The downstream slope was not inspected.
- b. The downstream slope appeared to be in fair to poor condition and requires corrective action.
- c. The down stream slope was not visible due to high grass and bush vegetation. Clear high vegetation and maintain low to enable easy visual inspection.

Photo 1 Downstream slope, heavy vegetation.

- d. Tree(s) were observed on the downstream slope. Trees have been identified as the probably cause of piping failures, and can possibly cause severe damage to the embankment if they are uprooted during a high winds. Corrective action is required to remove the tree hazards from the dam. Acceptable remedies include removal of the tree and its root structure down to a 2" diameter and reconstructing the damaged embankment section. All repair work shall be accomplished as per the requirements of licensed geotechnical or structural engineer. Routinely monitor the damaged area for signs of settlement and seepage.

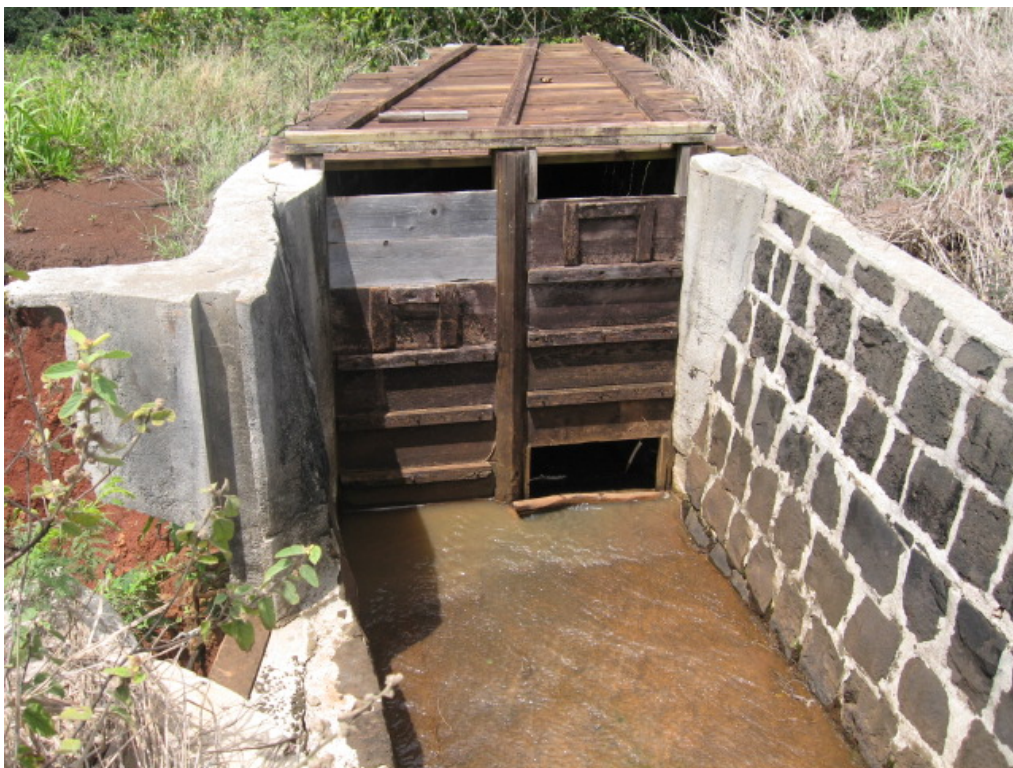
Photo 2 Spillway ditch inlet.

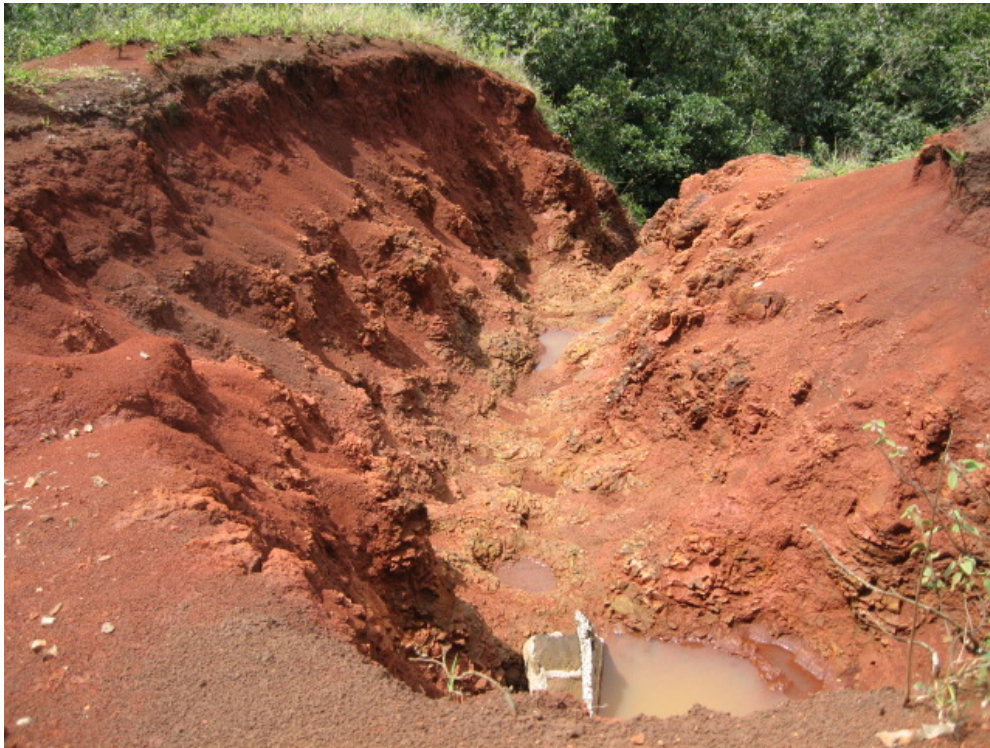
The spillway approach was clear. There was erosion observed near the spillway, which consisted of a deep head cut and scour. This erosion is located at the high level overflow and is severe. Further investigations should be conducted to conclude the capacity of the spillway.

- c. Severe scour erosion was observed which requires maintenance and/or repair. Description: There is severe erosion in the high level overflow channel and the spillway is being undermined. This needs to be repaired because the spillway may fail. Repair will be difficult due to the change in elevation from the spillway to the downstream channel.

Photo 3 High level spillway overflow erosion.

- f. Need to repair the spillway outlet channel and may need to find an alternate way to divert water downstream.

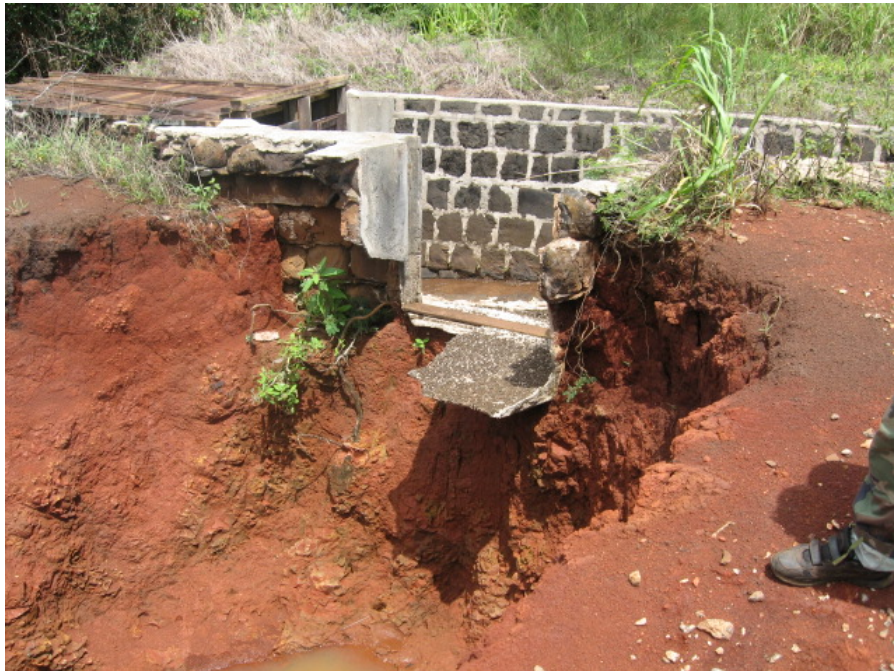
- a. The Spillway appeared to be in fair to poor condition and requires corrective action.
- b. At high flows the spillway appeared to be in unsatisfactory condition and not expected to fulfill its intended function. Urgent corrective action is required.

- d. A headcut was observed downstream of the spillway. Corrective / mitigative action is required to prevent this problem from moving upstream.
- e. Unclear if spillway is adequately sized. Spillway should pass the probable maximum flood. Verify spillway capacity and take corrective action as required.

Photo 4 High level spillway overflow, erosion, potential failure.

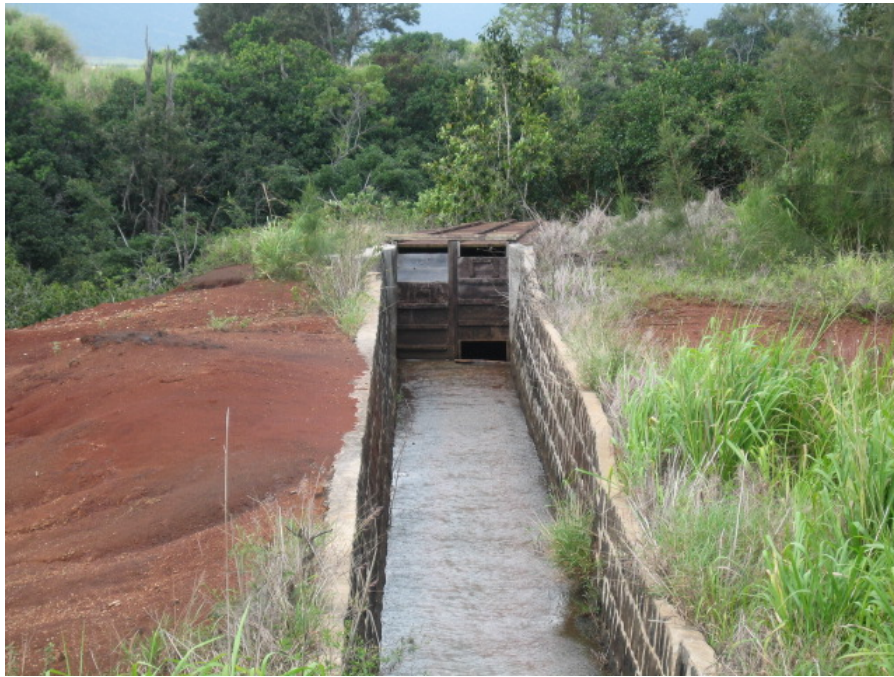
Photo 5 Spillway channel looking downstream.

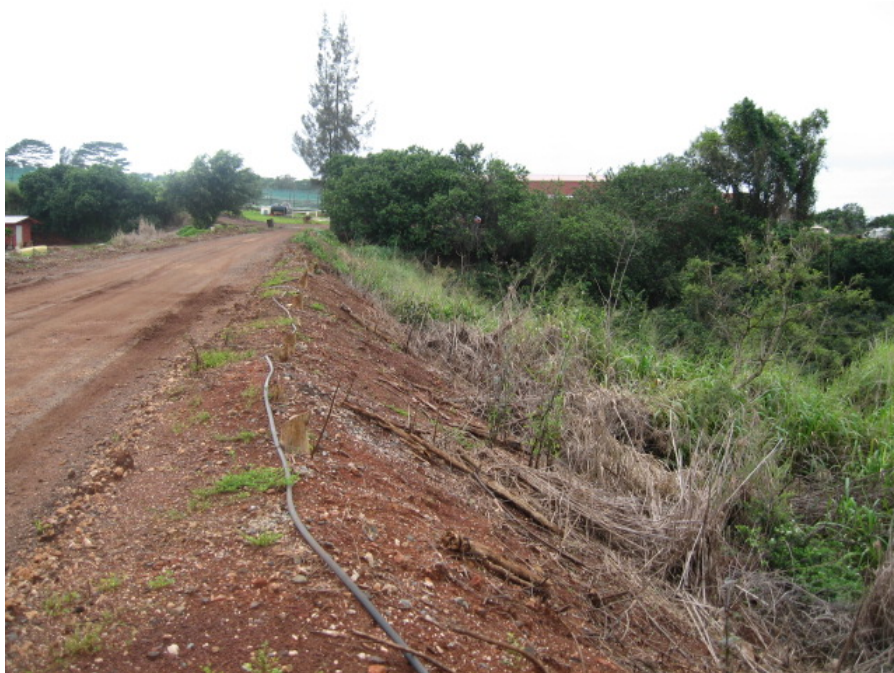
Photo 6 Downstream crest.

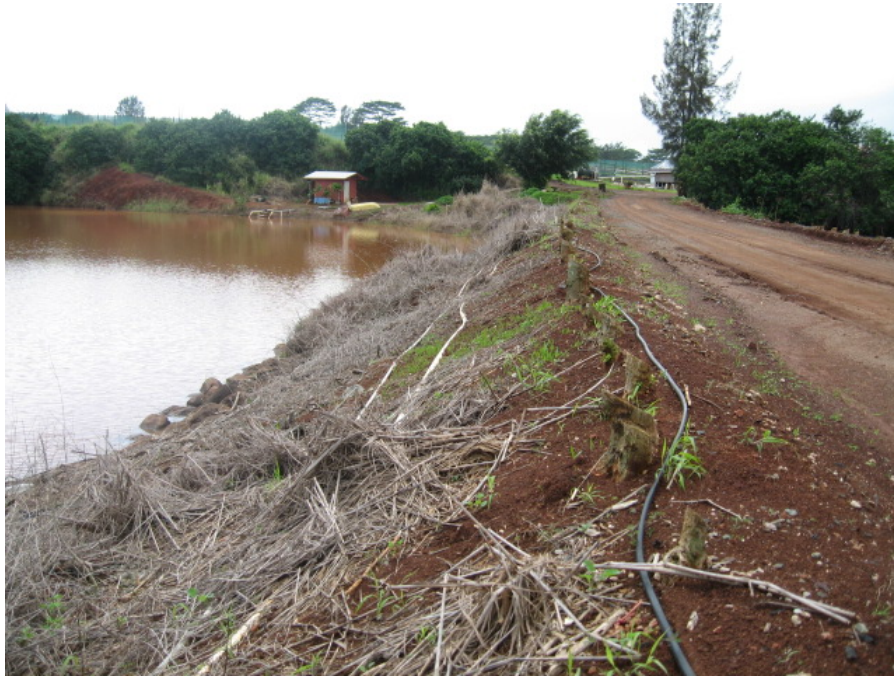
Dumped rock slope protection was observed at the toe of the slope. Vegetation was observed growing between the rocks.

- a. The upstream slope appeared to be in fair to poor condition and requires corrective action.
- b. Slope protection needs maintenance or repair. Description: Remove cut vegetation and restore low grass to limit any erosion.

Photo 7 Upstream face of dam.

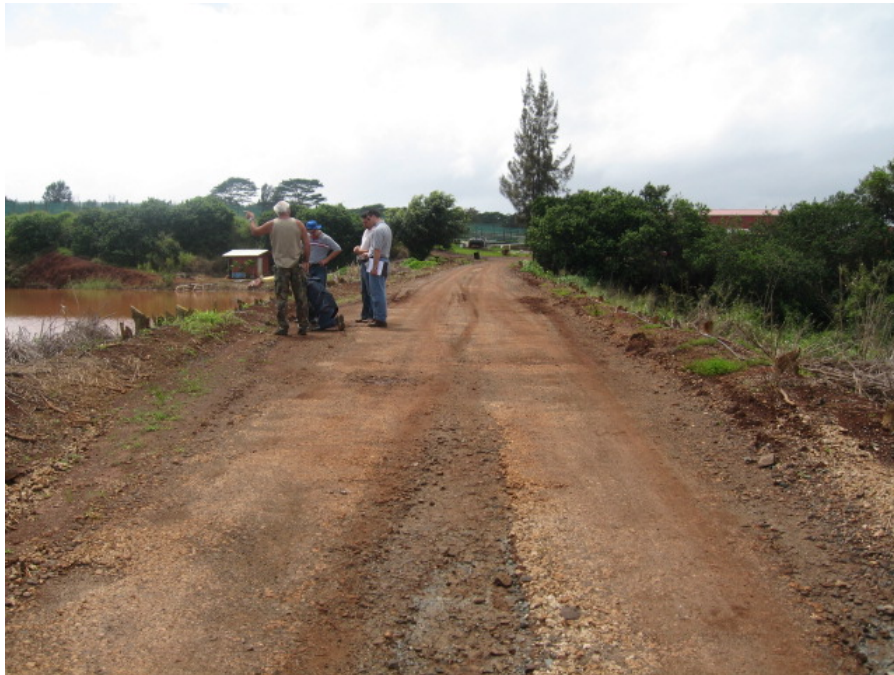
The crest of the dam was in good condition and well maintained.

- a. The dam crest appeared to be in satisfactory condition, no corrective actions are required at this time.
- b. Access along the crest was satisfactory.

Photo 8 Dam crest.

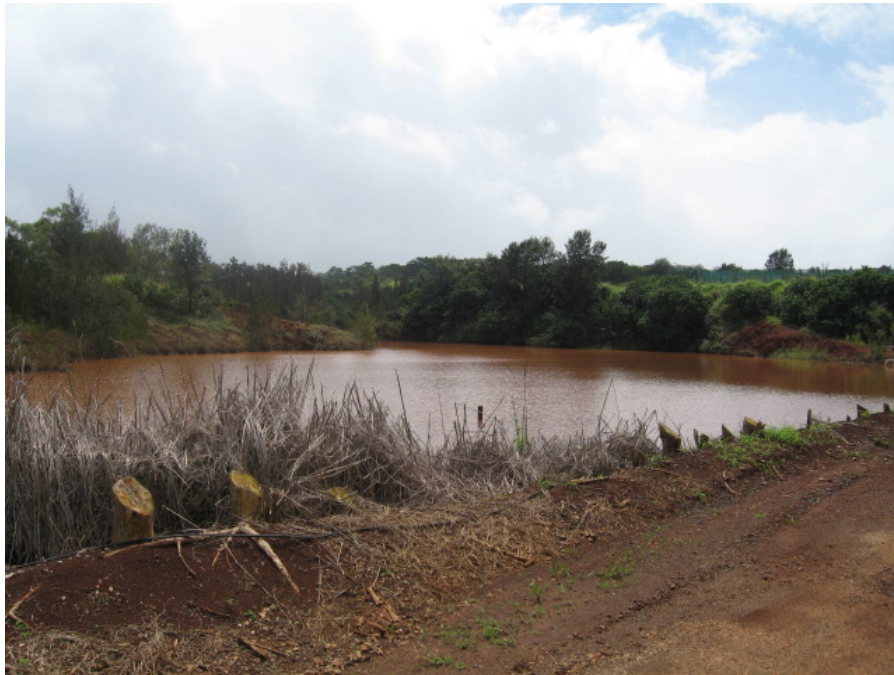
Photo 9 Reservoir overview.

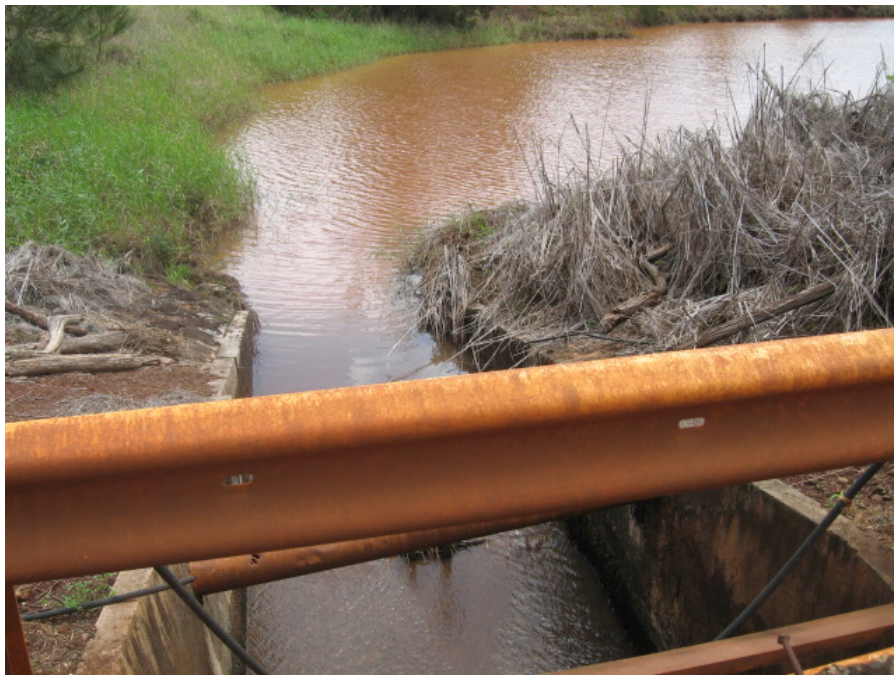
Photo 10 Upstream spillway entrance.

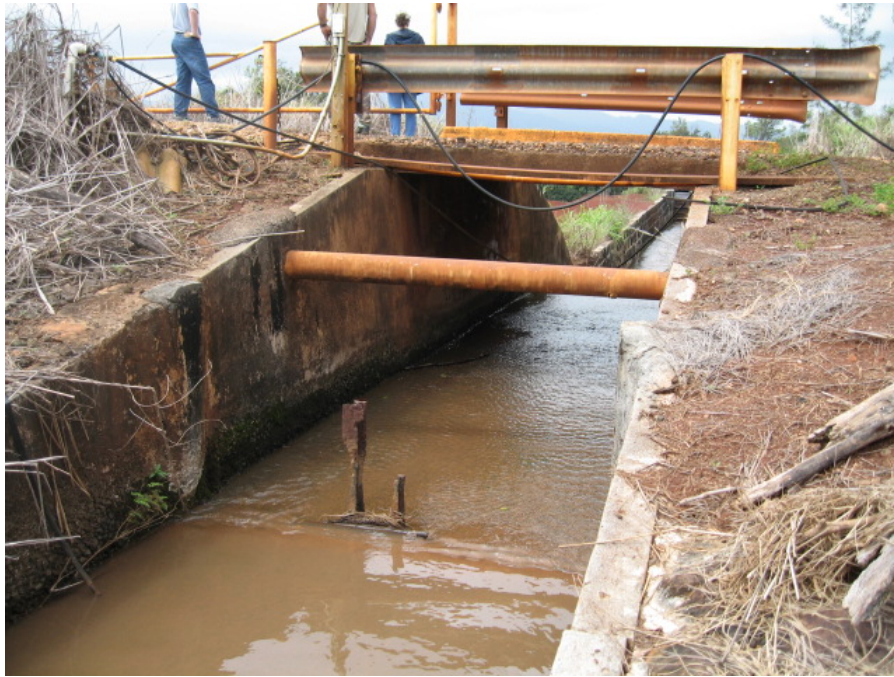
Photo 11 Spillway looking upstream.
